## 2023 ANNUAL ENGINEERING REPORT

| 3.1.1 PG&E Utility Bridge Removal – Eastside Canal..... | 8 |

## 1.0 INTRODUCTION

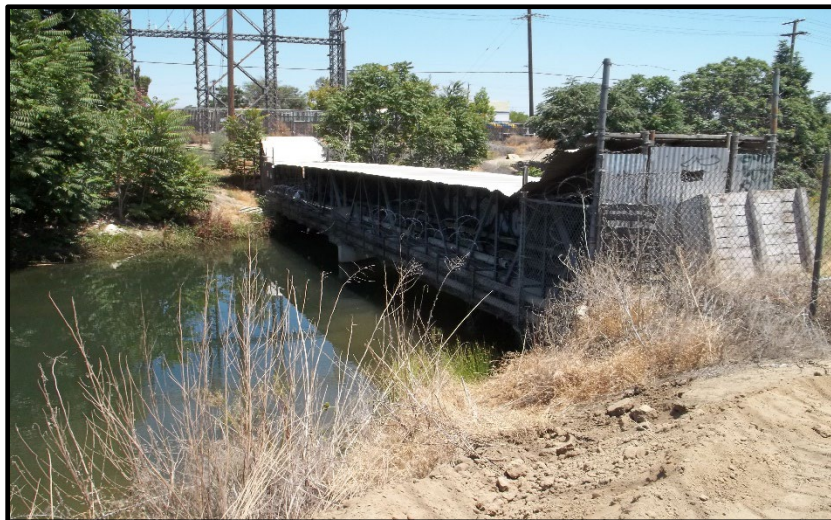
Photo 1: PG&E utility bridge, circa 2013

PG&E built a utility bridge in the late 1940's to carry fourteen electrical conduits across the Eastside Canal as shown in Photo 1 below. By the time the District reconstructed the east bank of the Eastside Canal in 2013, it became evident that the utility bridge was falling into disrepair and becoming a haven for the homeless. As only four of the fourteen conduits were active, PG&E and the District began discussing the abandonment of the utility bridge. The abandonment of the utility bridge required PG&E to obtain an overhead powerline easement from the District, coordinate the location of the new utility poles, and remove the bridge abutments and pier. The various stages of the removal process are shown in Photos 2 through 5 below.

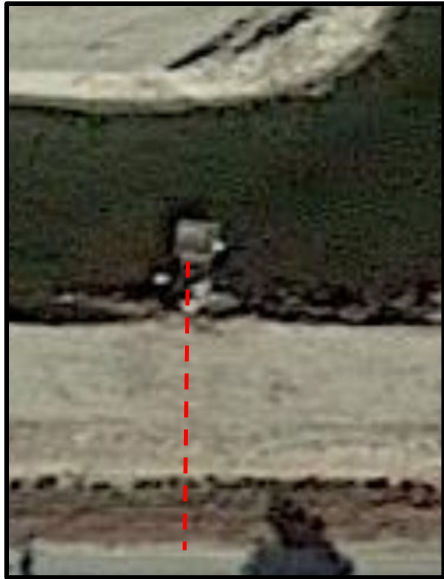
**Photo 6**

The 13 Ditch Return Canal's primary function is to regulate the water level in the 13 Ditch Main Canal via an overflow box structure just north of Shafter Road as seen in Photo 6 below. When the water level gets too high, the water will overtop the box structure, flow through a 24" Corrugated Metal Pipeline (CMP) into an open canal and then flow into the Kern Island Main Canal. In early 2023, the CMP failed at Shafter Road and thus needed replacement. While the District typically will not replace road crossings, due to the timing of the failure and the need to have both the 13 Ditch Main Canal and 13 Ditch Return Canal operational for its growers, the District took this opportunity to replace the pipeline and redesign the overflow structure as shown in Exhibit 13. Photos 7 through 12 show various stages of construction.

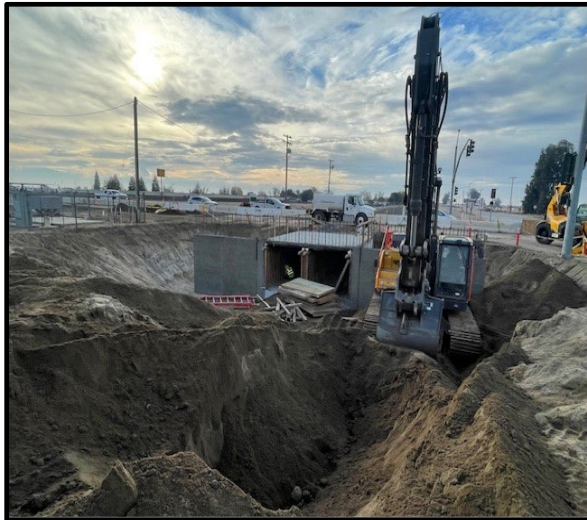
Photo 14

In 2020, engineers on behalf of Love's Truck Stop reached out the District to discuss solutions to accommodate an increase in traffic due to a proposed new truck stop on the northeast corner of Taft Highway and South "H" Street. Two options that were discussed were a potential bridge crossing the Kern Island Canal, approximately 170' north of Taft Highway, or extending the existing culvert farther north. Love's decided to extend the existing box culvert approximately 18' north to accommodate a right turn pocket. In addition to the reviewing the "Offsite Street, Sewer, and Storm Drain Plans", which included the box culvert extension and most of the proposed utility crossings of the Kern Island Canal, the District also reviewed the "New Travel Stop Water Main Extension Plan", which proposed a water pipeline to cross underneath the Kern Island Canal. After the District completed its review and approval of the plan sets and agreements were finalized and a Common Use Agreement was developed to allow the project to move forward. The culvert extension was completed during the 2023 Kern Island shutdown period. Photos 14 through 19 show the various stages of construction.

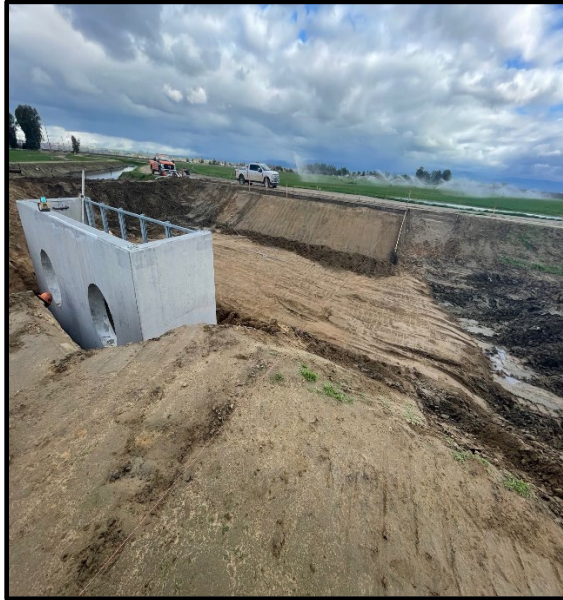
**Photo 20**

In 2022, Arvin-Edison Water Storage District (AEWSD) began to prepare plans for an intertie structure capable of transferring 40 cfs from their Forrest Frick Pipeline and Kern Delta Water District's Eastside Canal. The intertie structure is located approximately  $\frac{1}{4}$  mile south of Muller Road and a  $\frac{1}{4}$  mile west of Highway 184. The project was approved after going through Kern Delta Water District's review process. The Forrest Frick Pipeline Eastside Canal Intertie was completed and tested by the end of January 2023. Photos 20 through 22 show the various stages of construction and photos 23 and 24 show the intertie running water.

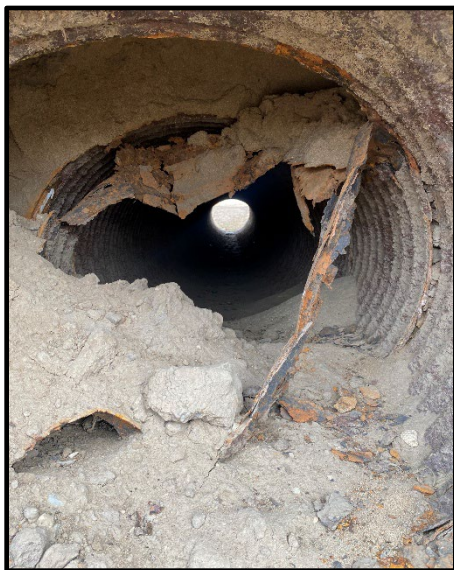
The Buena Vista Boulevard crossing of the Eastside Canal consisted of three corrugated metal pipes. In December 2022, District staff informed the Kern County Roads Department (County) that the Buena Vista Boulevard crossing of the Eastside Canal was starting to fail. In particular the center pipe at the south headwall, as seen in photo 36 below, and requested the County's plan for replacement. The District also put the County on notice that, should the crossing fail, while the District was running water, the District would remove the crossing and continue to flow water. In February 2023, the District informed the County that a sinkhole was forming behind the southerly headwall as seen in photos 37 and 38. By middle of March, the County performed a hard closure of Buena Vista Boulevard and by the end of March, the Buena Vista Boulevard crossing completely failed. On March 27<sup>th</sup>, the District removed the corrugated metal pipes (leaving the headwalls intact), shaped the canal and installed rip-rap protection along the sides of the canal (see photos 40 and 41). By March 29<sup>th</sup>, the Eastside Canal was flowing water again (see photo 42), and was able to flow the entire season. The District and the County are working together on a replacement strategy (timing, size of culvert, etc.). The complete culvert replacement is expected in early 2024.

Photo 36: Center culvert pipe, looking north.

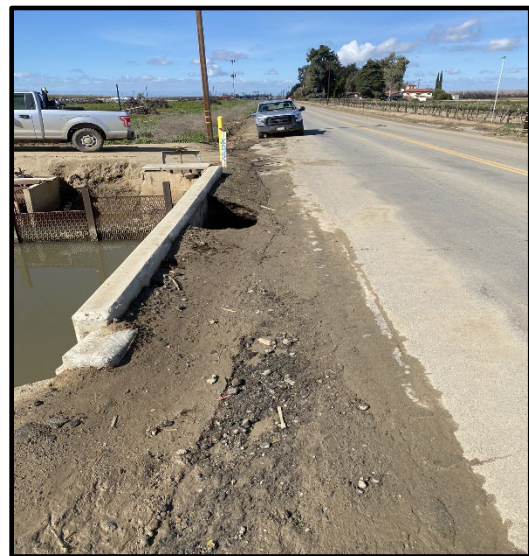
Photo 37: Eastside Canal crossing at Buena Vista Blvd, looking east.

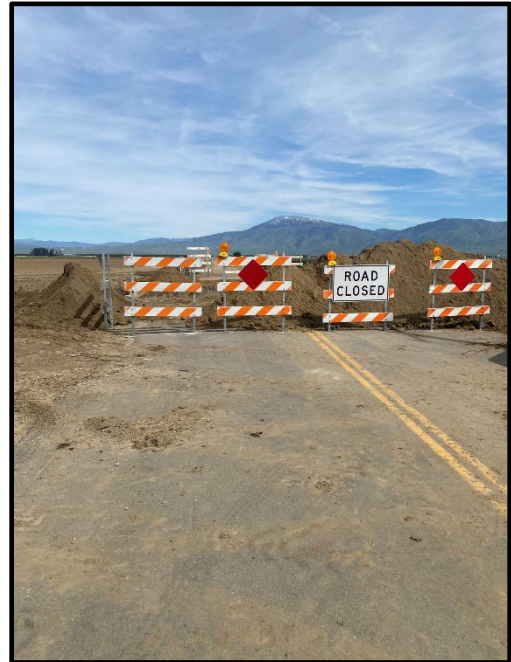
**Photo 39: Buena Vista Blvd closure.**

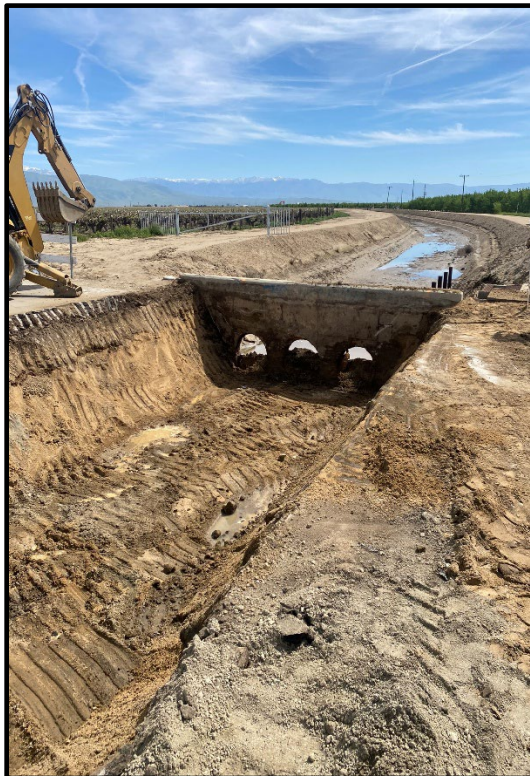
**Photo 40: Crossing removed, canal shaped, looking south.**

- d. Removed Buena Vista Blvd crossing (pavement, dirt and rusted corrugated metal pipe) at the Eastside Canal. Made an open canal between the headwalls.

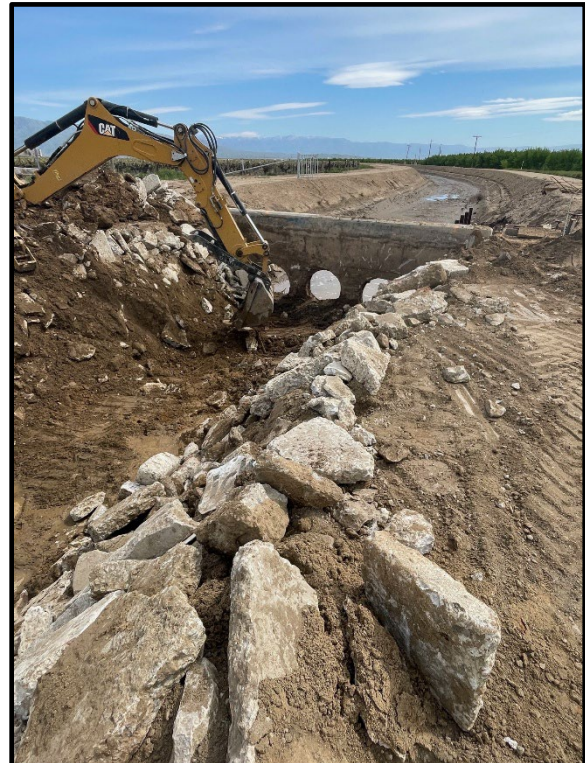
**Photo 41: Rip-rap installed, looking south.**

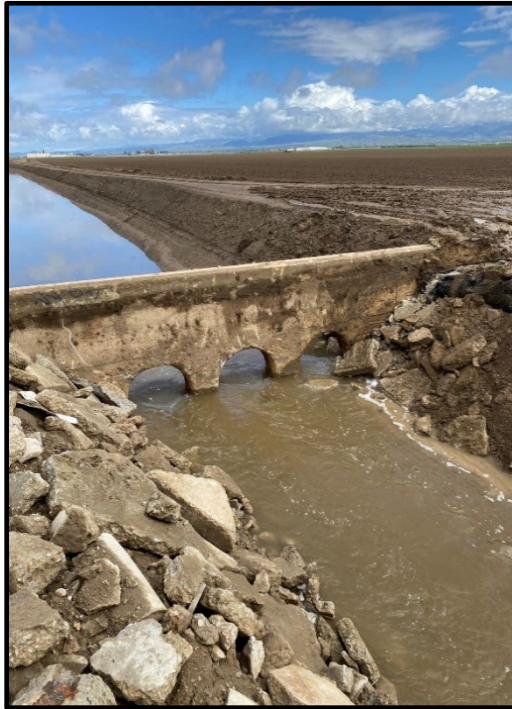
Photo 42: Eastside Canal flowing again, looking north.

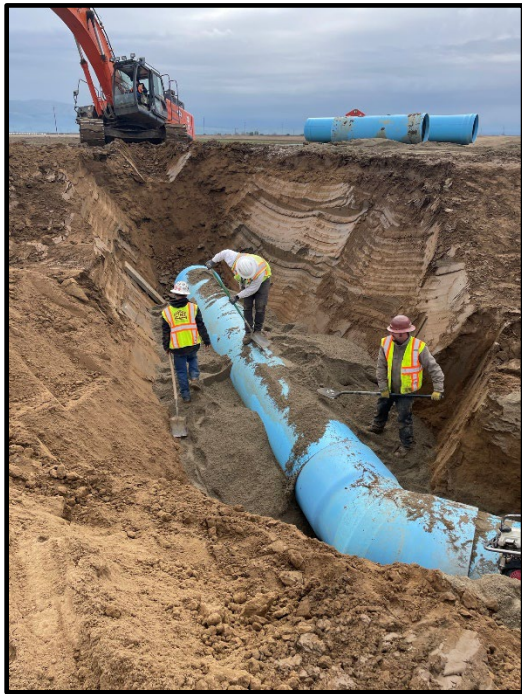
With the construction of the pond levees, inter-basin structures, and the gravity inlet/outlet structure into Pond 4 complete, the project moved into the next phase, which included the construction of the pump inlet, structure pumping station, installation of the main 36-inch diameter pipeline, installation of two discharges, one into Pond 1 and the other into Pond 2. Overhead power supply to the pump station as well as installation of the three pumps is expected to be completed in early 2024. Photos 54 through 66 show the various stages of construction

Photo 54: Installation of discharge into Pond 1

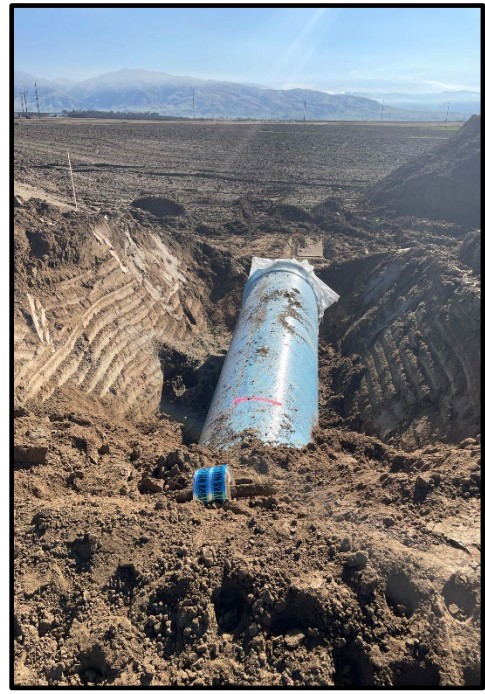
Photo 55: Discharge into Pond 1

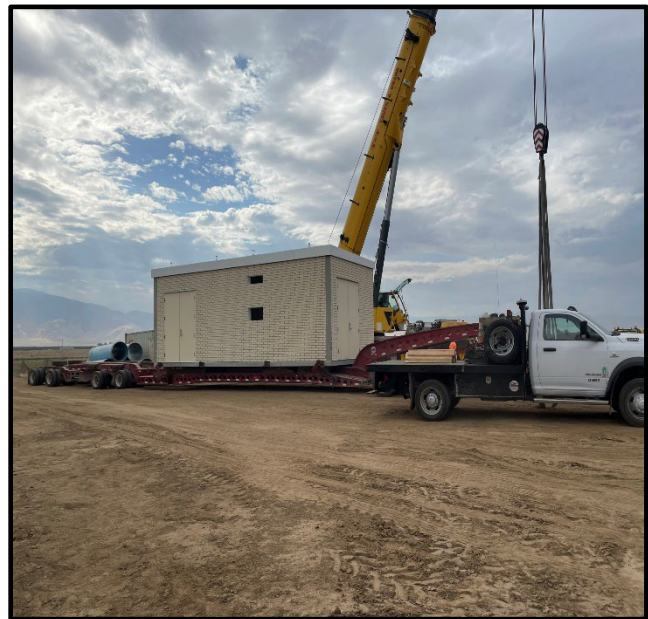
**Photo 57: Pump House arrives on site.**

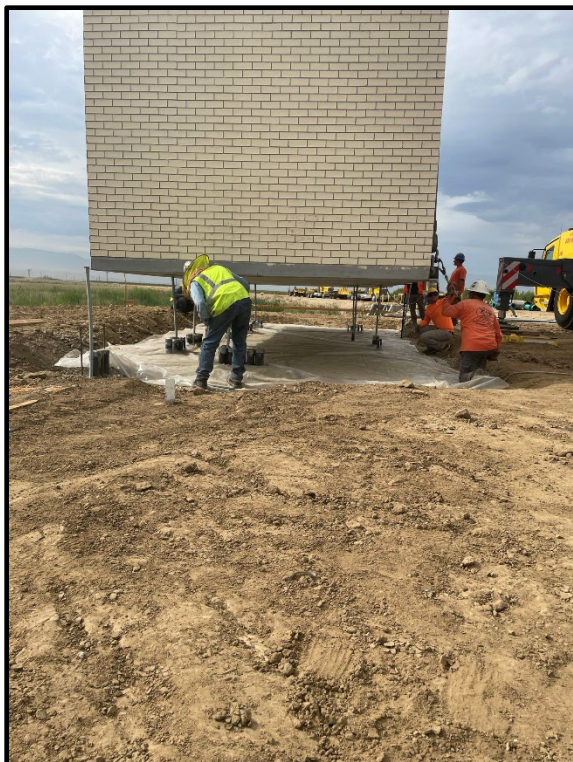
**Photo 58: Setting Pump House.**

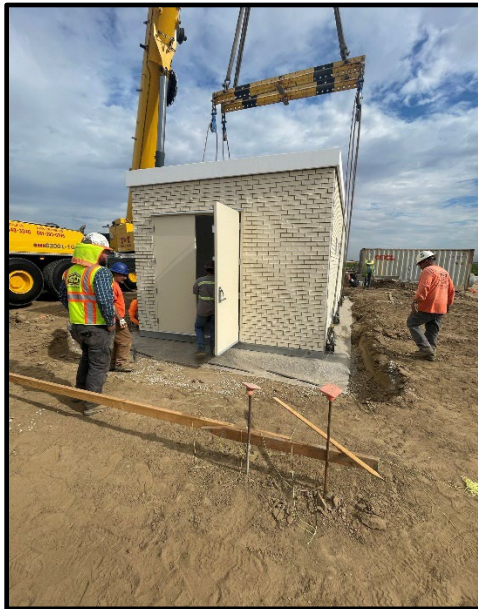
**Photo 59: Pump House set.**

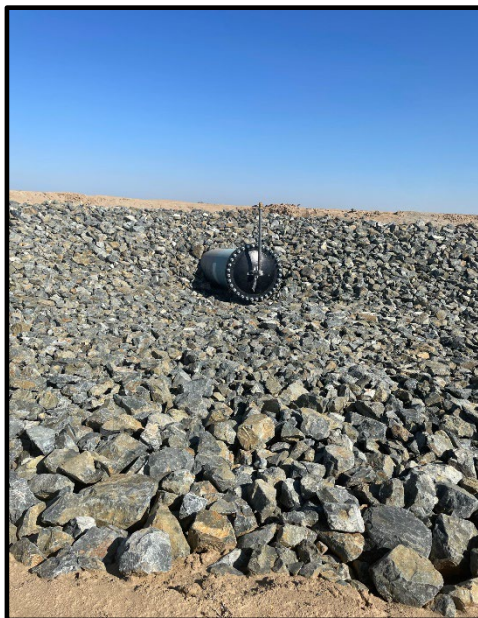
**Photo 61: Discharge into Pond 2 with rip/rap.**

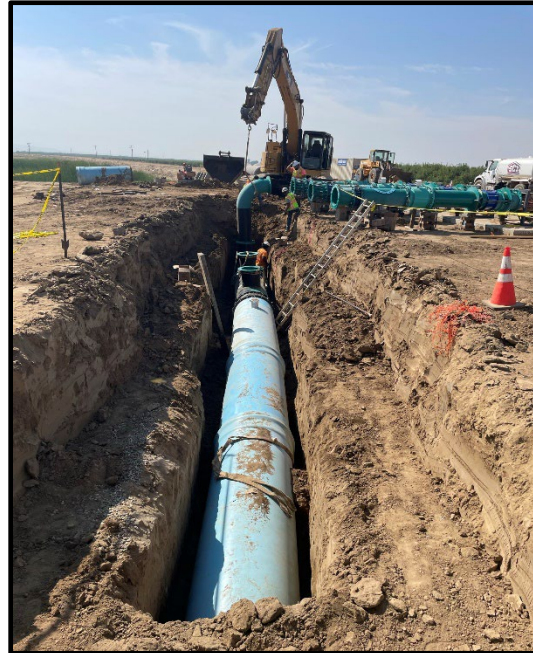
**Photo 64: Pump discharge tie-in to 36" main line.**

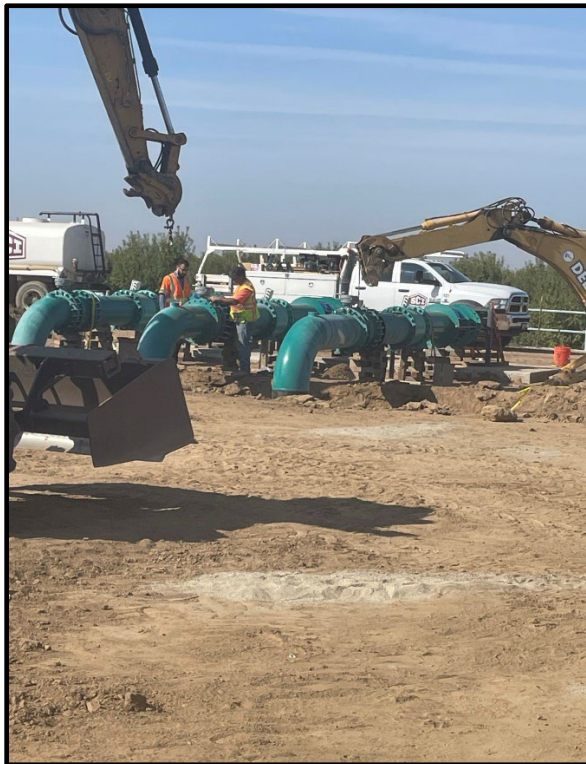
**Photo 65: Pump discharge construction complete.**

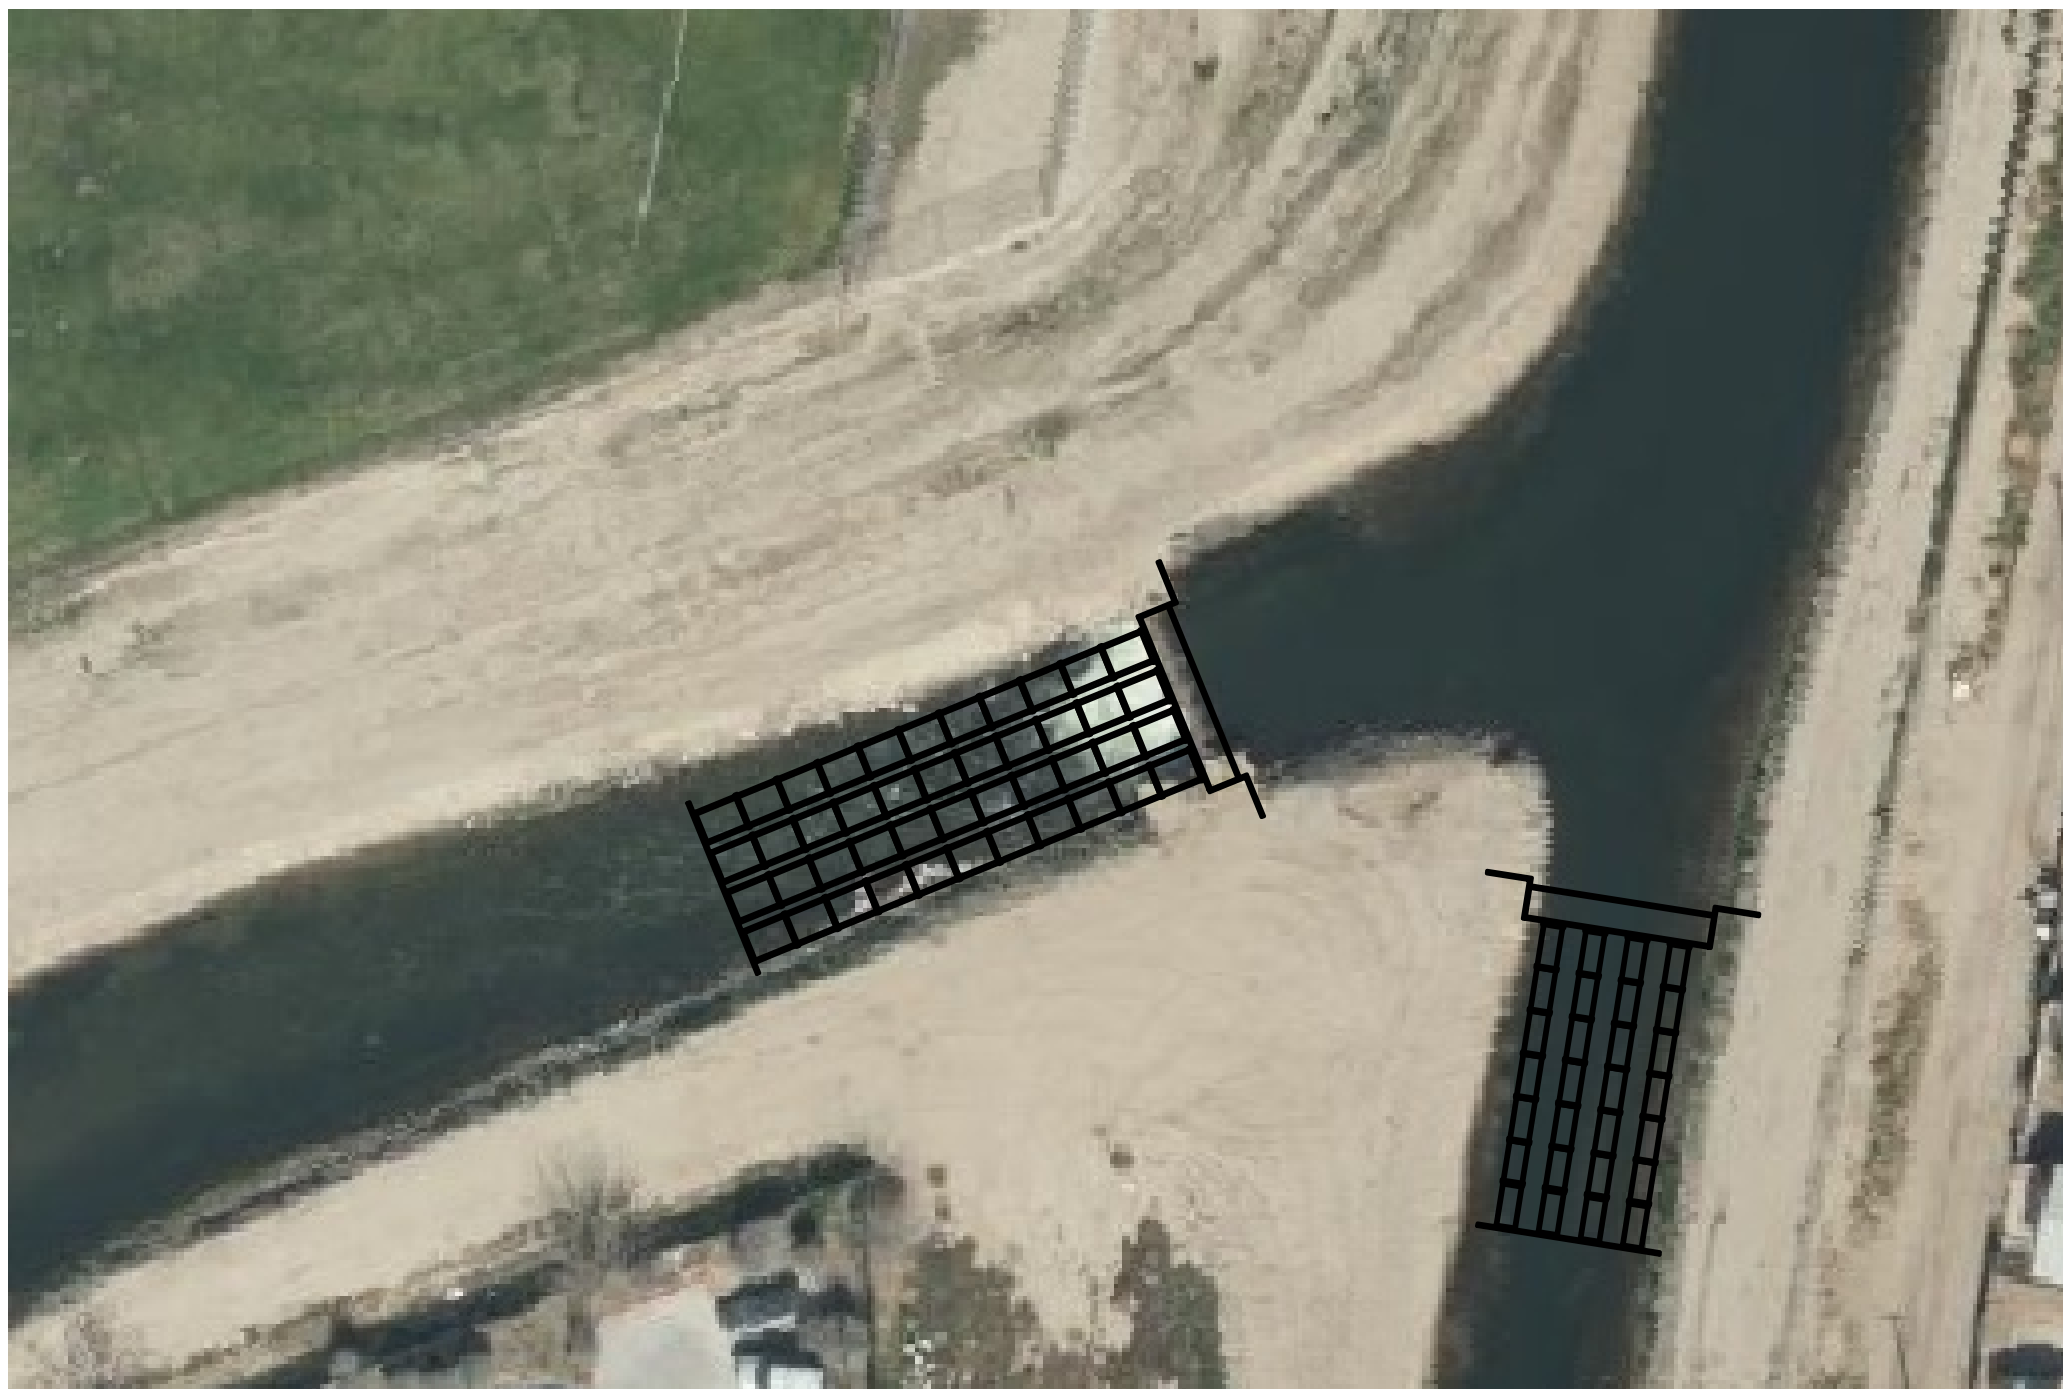
**EXHIBIT 14  
KERN ISLAND & CENTRAL  
PROPOSED MODIFICATIONS**

not have adequate control to regulate flows into either canal. The District plans to remove the existing weir in the Kern Island Main Canal and replace it with structures that will regulate flows into either canal. These structures will also be constructed to provide adequate relief during time of high flows or other operational concerns. A preliminary conceptual design is shown in Exhibit 14.
